Section A3

OPTRONIC^â & PERFORMANCE IGNITION SYSTEMS

Technical Bulletins

Technical bulletins on the installation and operation of Optronic contact breaker replacement ignition systems.

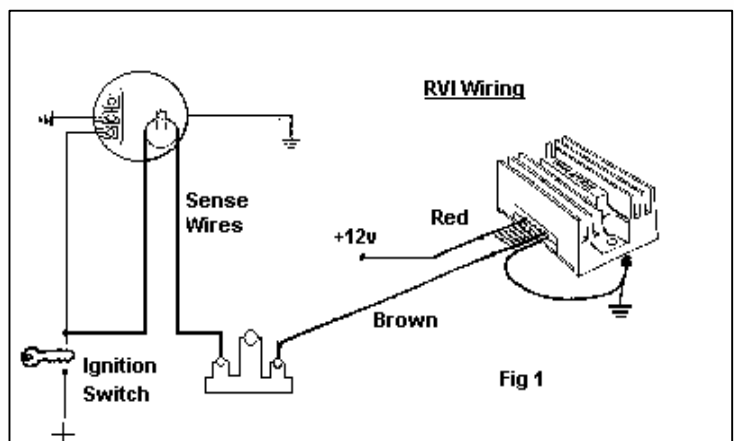
Before 1974 (approx.) the electronic tachometer were current impulse triggered. This means the tachometer sense wire is connected in series with the ignition coil, usually between the ignition switch and coil/ballast positive as in Fig 1. Sometimes the power for the tachometer was shared internally with the ignition switch end of the sense wire giving only three terminals. Smiths unit of this type can be identified by the letters RVI on the face of the tachometer. Designed in the days of contact breakers, they give inconsistent results when used with electronic ignitions. Many installations will work but some will produce erratic or no movement of the indicating needle. Some suggestions for rewiring the ignition circuit to eliminate the problem have been tried with limited success.

As mentioned above some owners have tried alternative wiring for the sense wires with RVI tachometers with limited success. Lumenition's recommended solution is either to:

- Replace the RVI tachometer with a later RVC model if available or aftermarket equivalent or
- Convert the existing RVI tachometer to new internal electronics.

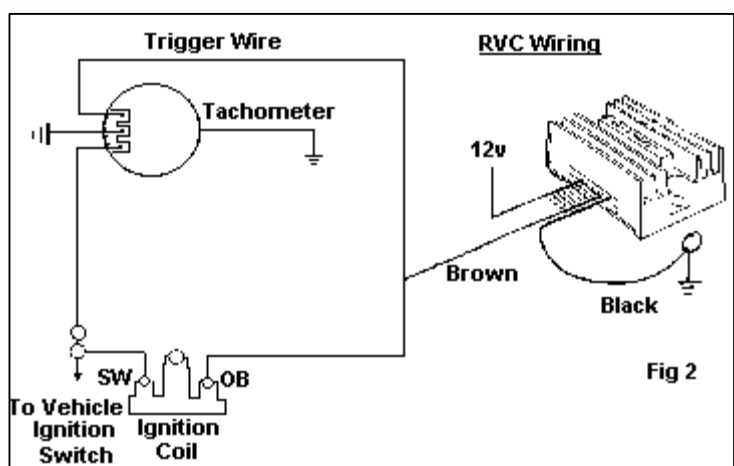
Later electronic tachometers are voltage pulse triggered and the single sense wire is connected directly to coil negative as in Fig 2. Smith unit have the designation RVC printed on the face. As far Lumenition are aware there are no problems using this type of tachometer with our Optronic ignition.

It is important that owners can tell the difference between the two types of tachometer as incorrect wiring of the unit can cause damage to the electronic ignition module. If used the tachometer sensing wire(s) must be connected as appropriate for that particular design of tachometer.
