Section A3

OPTRONIC^â & PERFORMANCE IGNITION SYSTEMS

Technical Bulletins

Technical bulletins on the installation and operation of Optronic contact breaker replacement ignition systems.

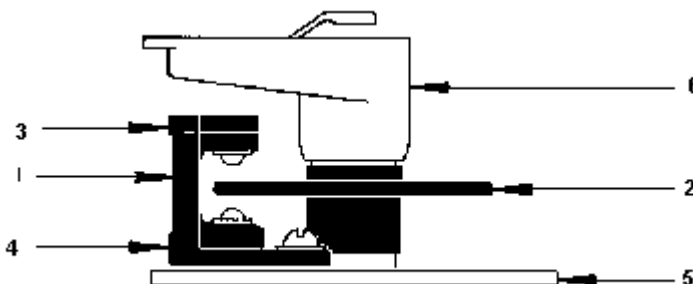
Ensure that the chopper (2) is fully seated onto the distributor shaft and located so that the chopper blades are approximately mid-way between the optical switch lenses (3 & 4).

1	Optical Switch	2	Chopper	3	Photo Transistor
4	Light Emitting Diode	5	Base Plate	6	Rotor

Make sure the optical switch wires are clear of the chopper blades and suitably secured. **ESPECIALLY** when the vacuum advance is fully operated. As the vacuum advance moves the wires slightly in operation, take care to make sure the wires are kept away from chopper blade but do not interfere with movement of the advance mechanism.
